TS-PIC-93810  
February 1993

# AERIAL PHOTOGRAPHIC ANALYSIS OF THE NASA JET PROPULSION LABORATORY Pasadena, California

EPA Region 9

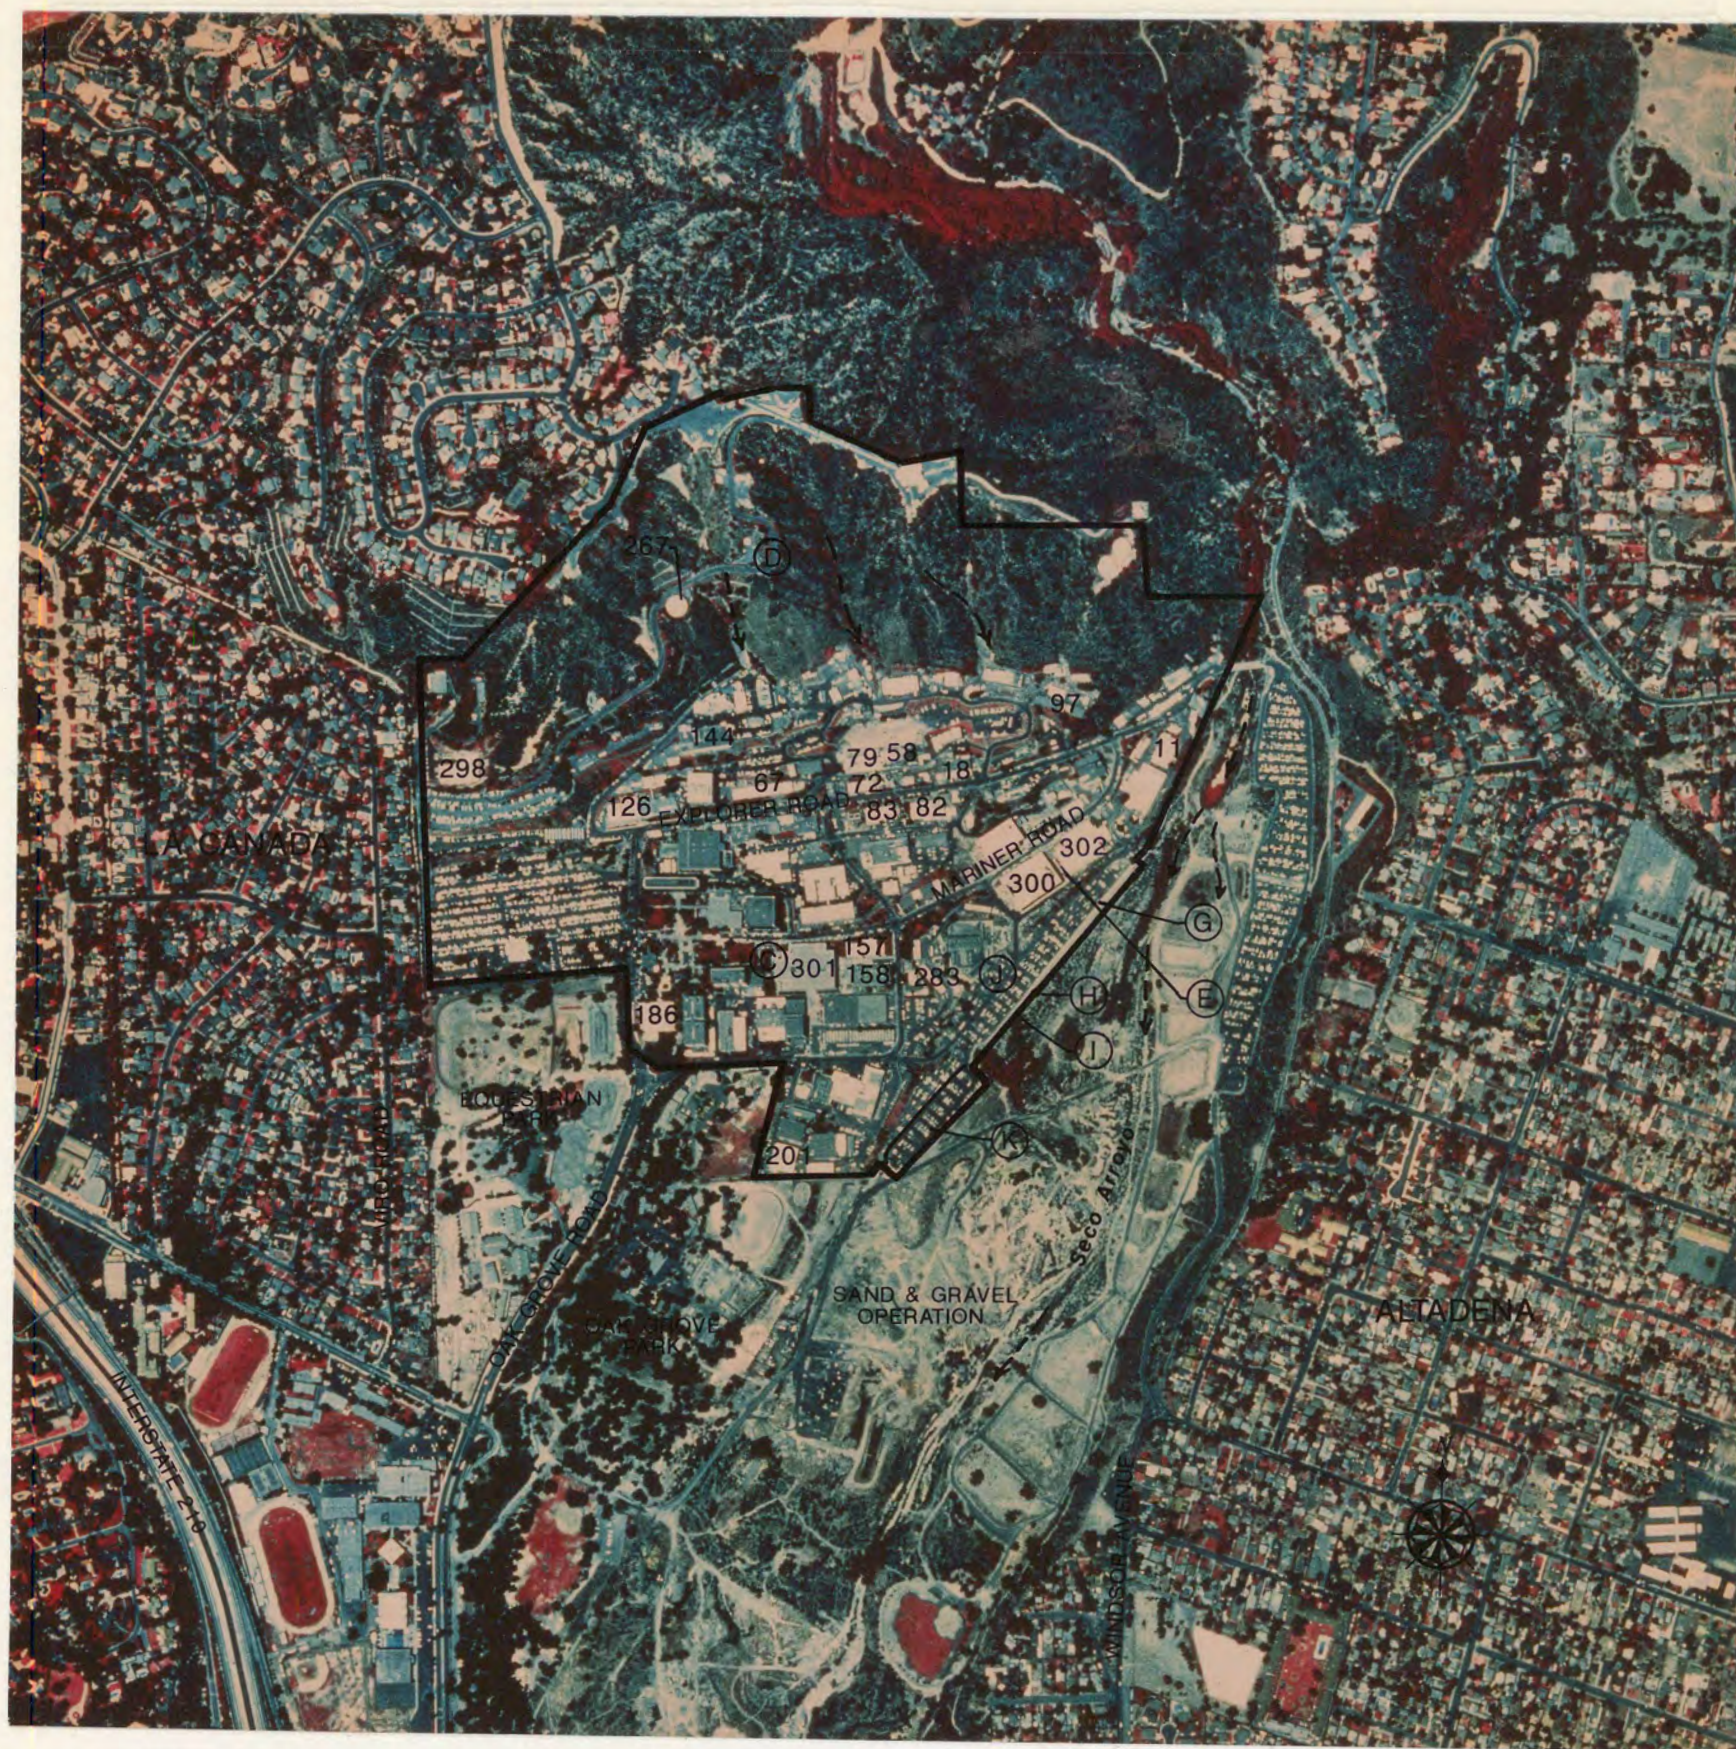
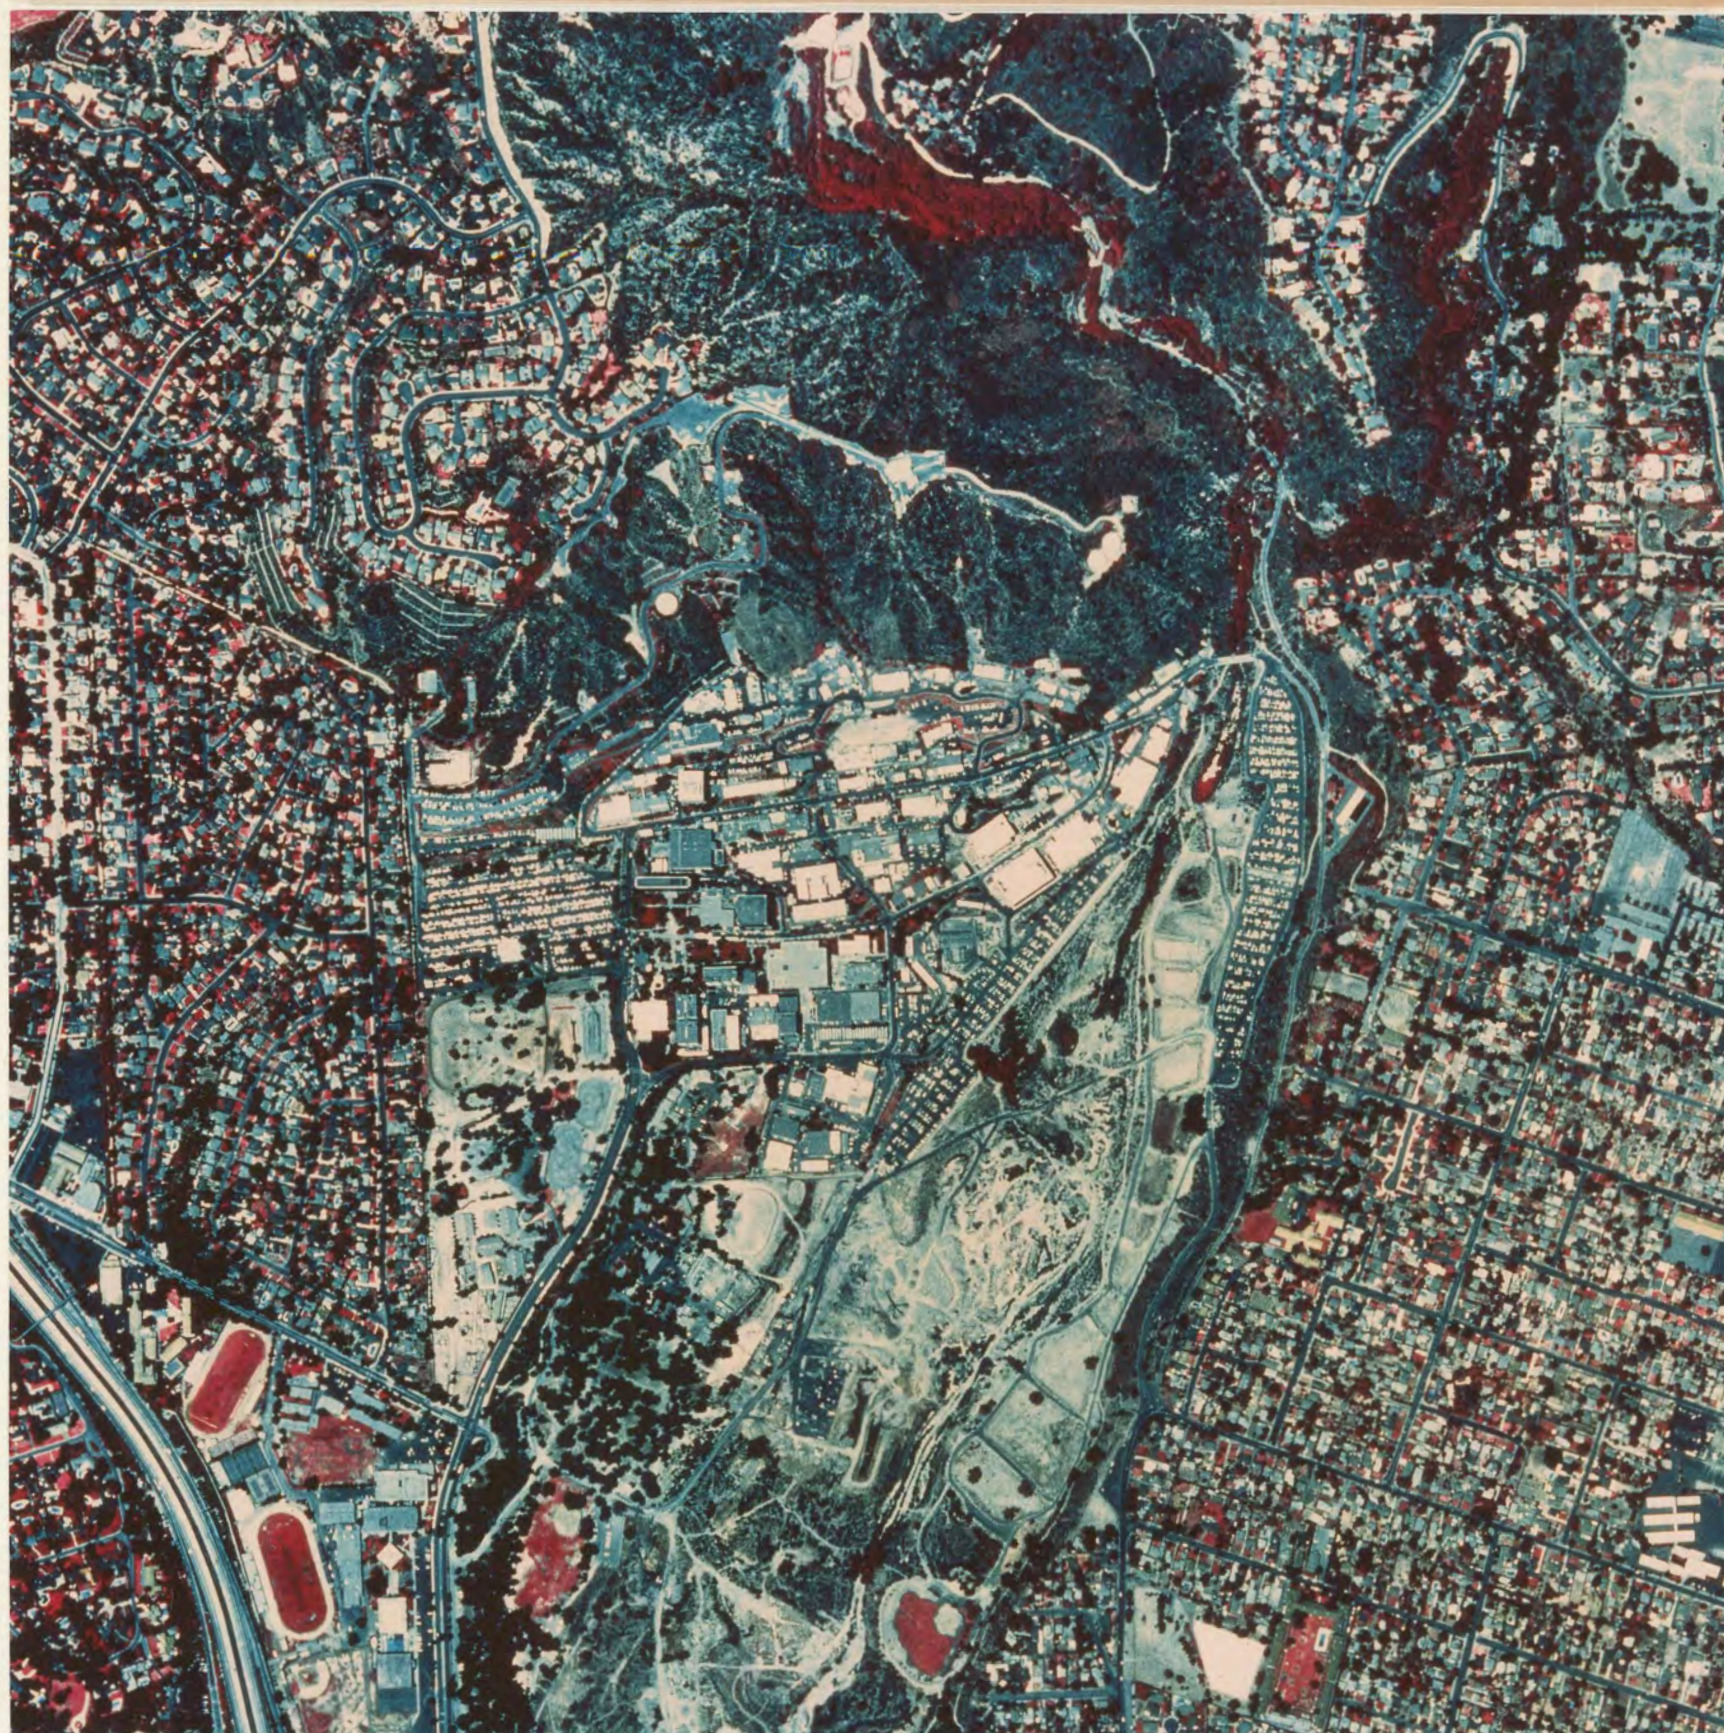
Figure 13. NASA Jet Propulsion Laboratory, August 3, 1989.  
Approximate scale 1:9,970.

The locations of previously reported features and those previously annotated JPL buildings are annotated as reference locations (Annotations A through J). The shape and size of several of these buildings have been modified and/or demolished to make space for ongoing construction. The 1989 photograph reveals continued construction has occurred at the JPL study site since 1985. Two additional buildings are first noted on the 1989 photograph (Annotations 300 and 302). The parking lot at the southeast corner of the study site has been enlarged (Annotation K). No operating waste disposal units are observed.

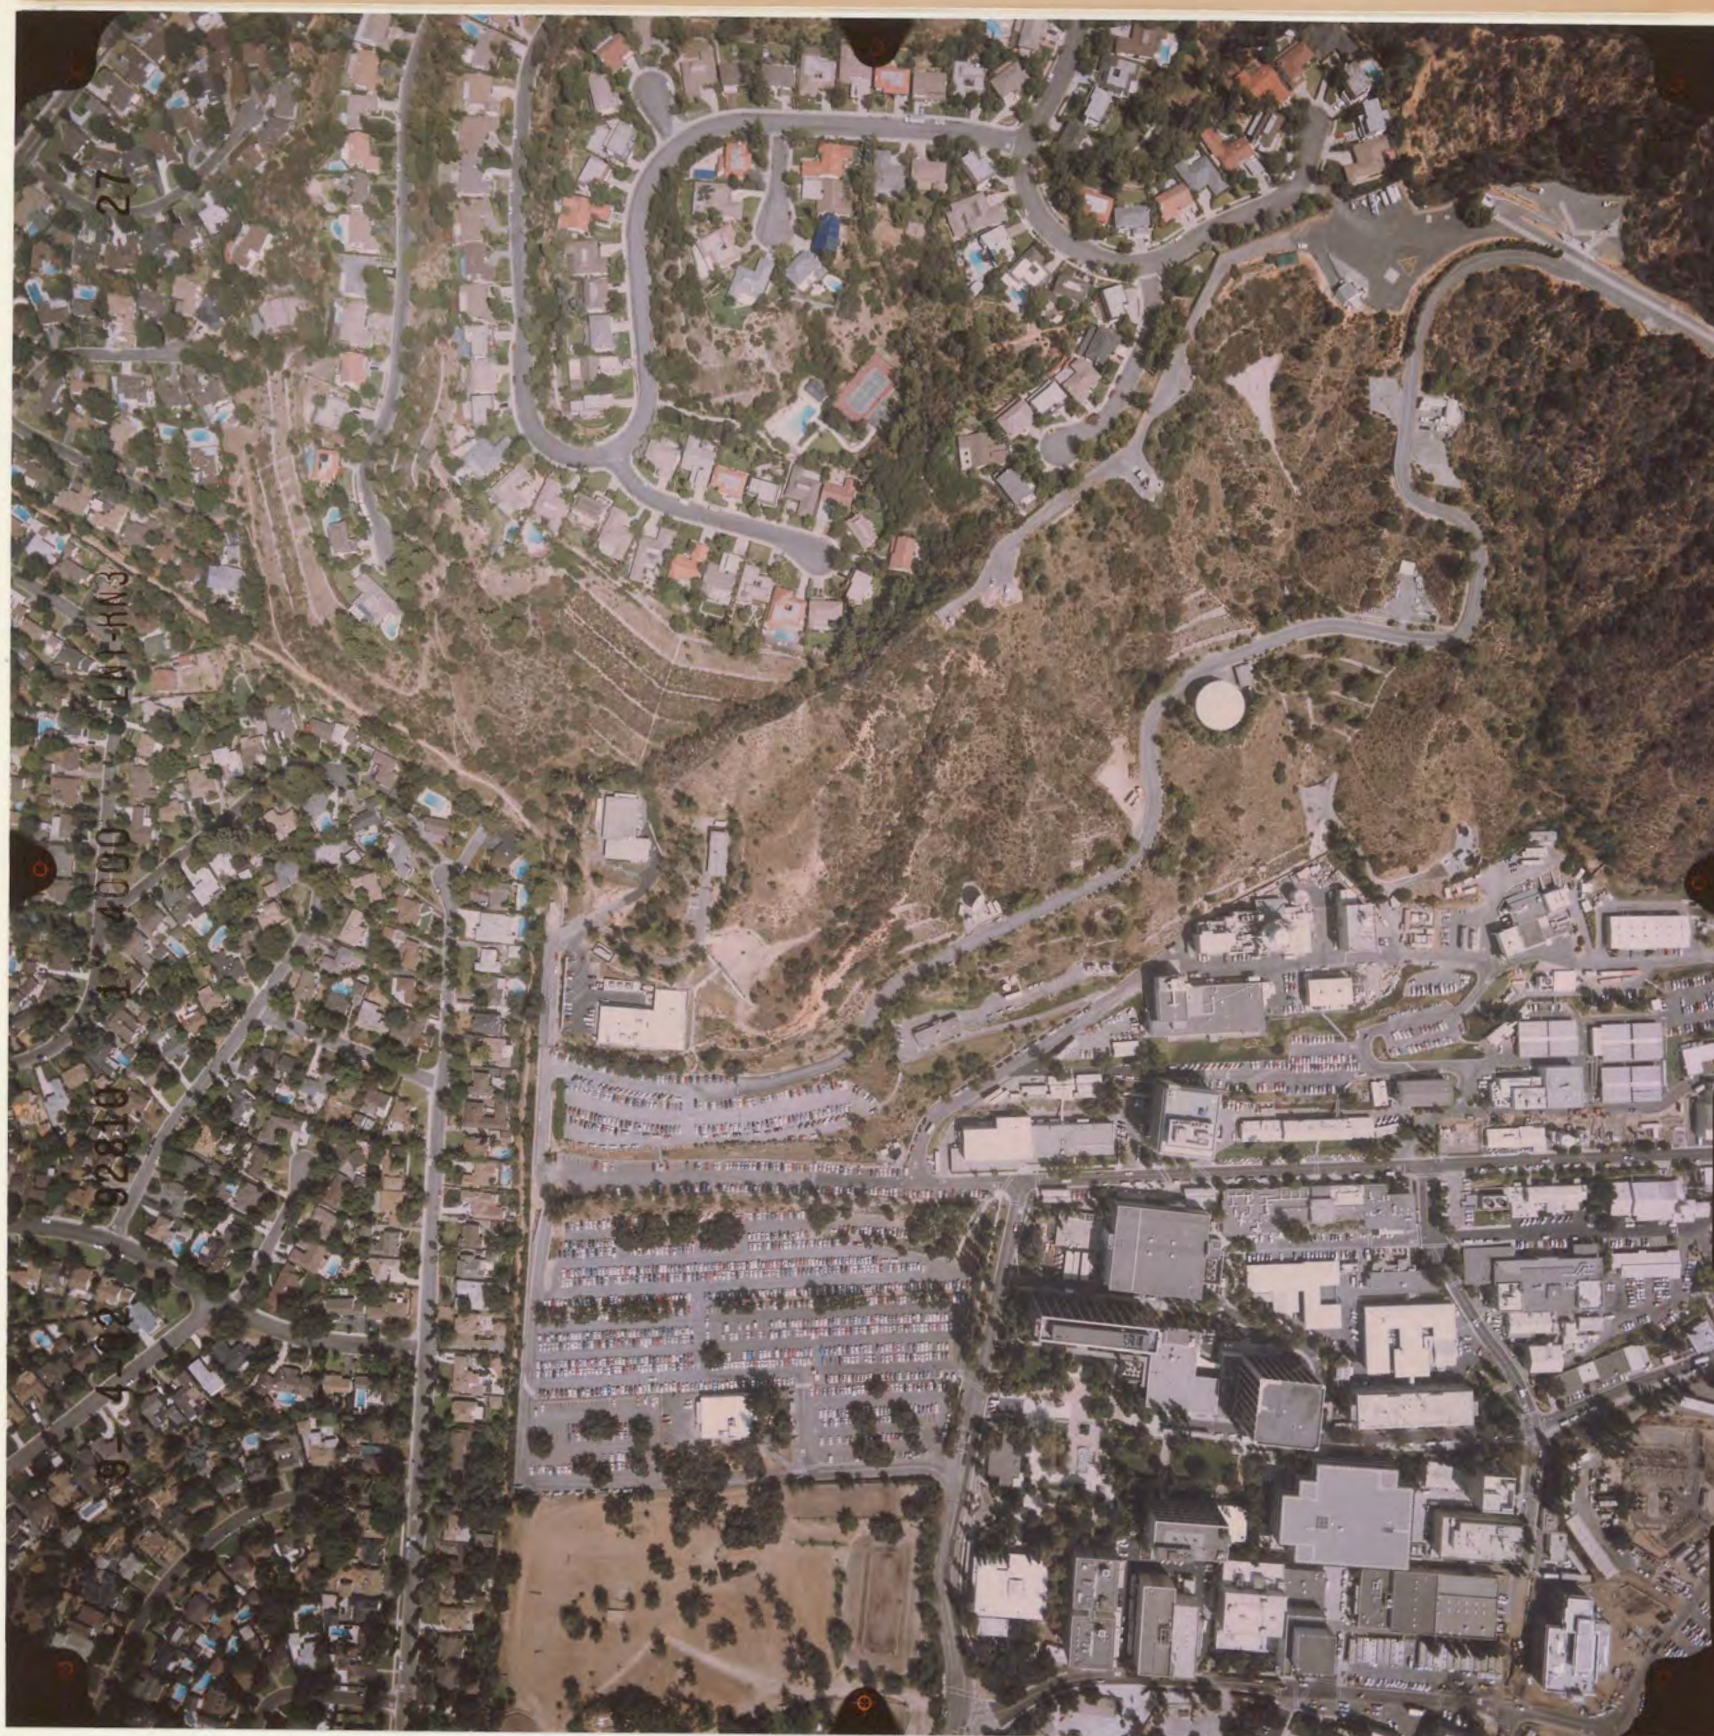
Figure 14. NASA Jet Propulsion Laboratory, September 4, 1992 (1 of 4).  
Approximate scale 1:4,000.

The 1992 low altitude, color photographs, with their improved photographic resolution and photo scale, provide a greater amount of information about the JPL facility. The previously reported features and building numbers noted on the earlier photographs (Annotations A through K) are also annotated on this photograph as reference points.

Several storage tanks are discernible throughout the facility and are annotated. These storage tanks could contain fuels, solvents, reagents, lubricants or other compounds that could pose pollution threats to the environment in the event of spillage or leakage. No visible evidence of spillage or leakage was noted. No operating waste disposal units are observed.
